# Fact Sheet

## Wilbur Kitchen Dishwasher Water and Energy Monitoring Project

Stanford University

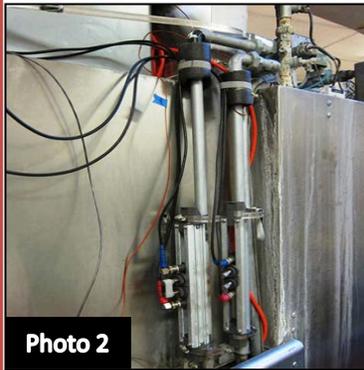
Photo 2

Ultrasonic metering equipment (Photo 2) and thermocouples were placed on incoming water lines inside the dishwasher to collect data on water consumption and temperature.

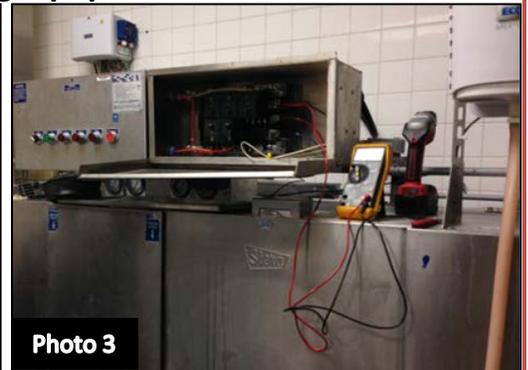
Photo 3

Data from the ultrasonic water meters, current transformers, and thermocouples was wirelessly transmitted to a database for analysis by FSTC staff. The old dishwasher was monitored for three weeks before its removal.

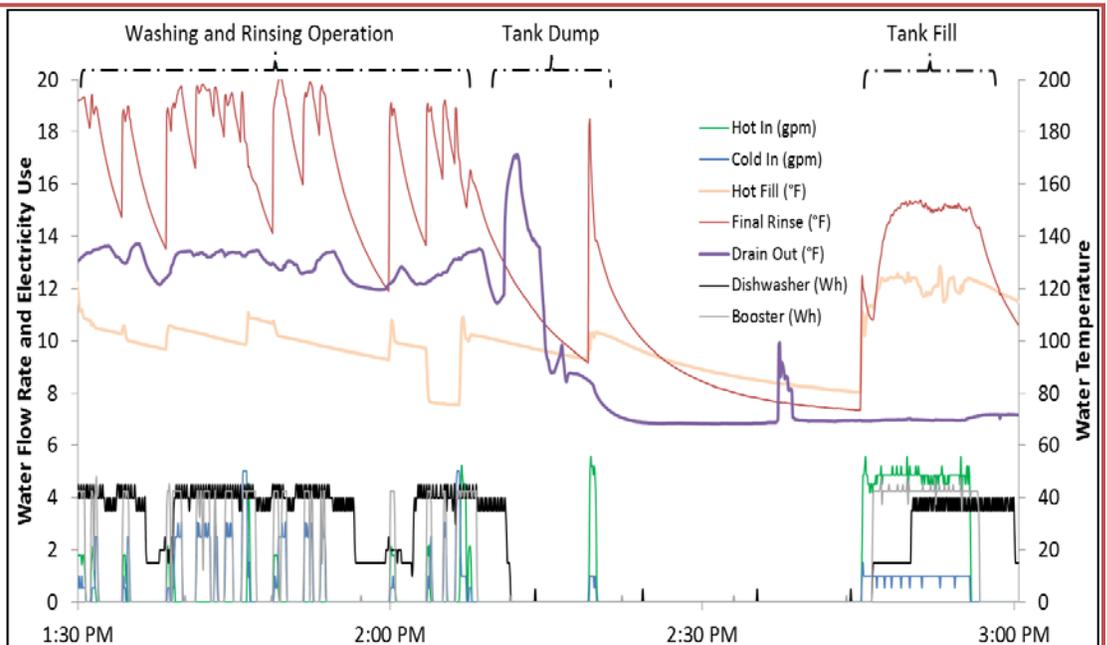
Figure 1- Data from water use and temperature

The old and new conveyor dishwashers being studied in this project have three internal compartments for prewashing, washing, and rinsing wares. The graph in Figure 1 shows temperature and water use readings from the inlet hot and cold water lines and dishwasher electricity use.

Based on the timing, intervals, and placement of the sensors, FSTC was able to identify the water use for tank fills, tank top offs, or for final rinse, and determine if the machine was working effectively.

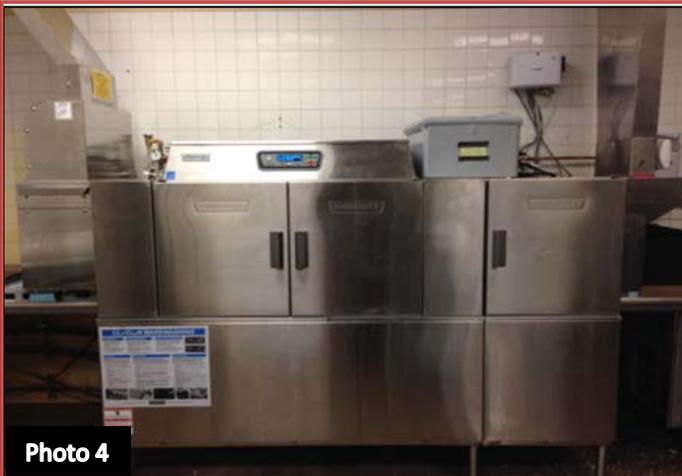
Photo 4

The original dishwasher at Wilbur Dining was replaced with a more efficient machine (left) on December 23, 2014. The new machine uses hot water instead of steam and is equipped with a heat recovery unit to maximize efficiency. The new machine is smaller and more appropriately sized for the kitchen as the previous machine was oversized. After the first month of analysis, the new machine showed a reduction of 54% in water use and 64% in energy use.

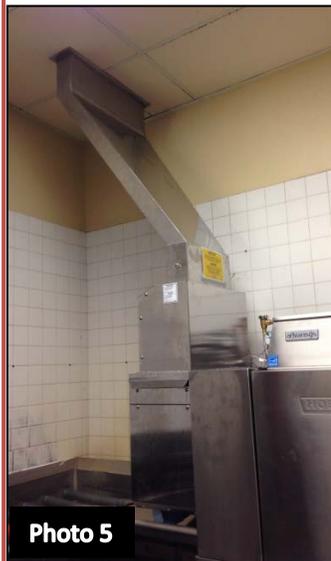
Photo 5

The heat recovery unit on the new dishwasher minimizes heat loss by capturing steam created during the rinsing process and condensing it to preheat the incoming cold water, which is then used in the final rinse. This process reduces the amount of water needed for rinsing as well as the energy needed to heat the water. The machine also includes an automatic shut off that stops the machine from running and wasting water if the conveyor gets stuck due to the 90 degree turn on the exiting side of the conveyor belt.

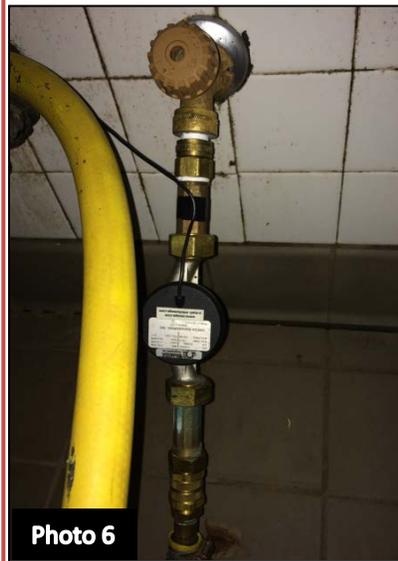
Photo 6

To obtain a complete understanding of water use and dishwashing practices in the dish room, FSTC installed water meters on three hoses located in the kitchen which are used for cleaning floors, pre-rinsing the dishes, and cleaning the dishwasher. By monitoring the hose use, FTSC was able to recommend improvements and suggest best management practices (BMPs). Even with new hardware, BMPs are essential to improve efficiency.

A close up of the metering equipment on the hoses (Photo 6).

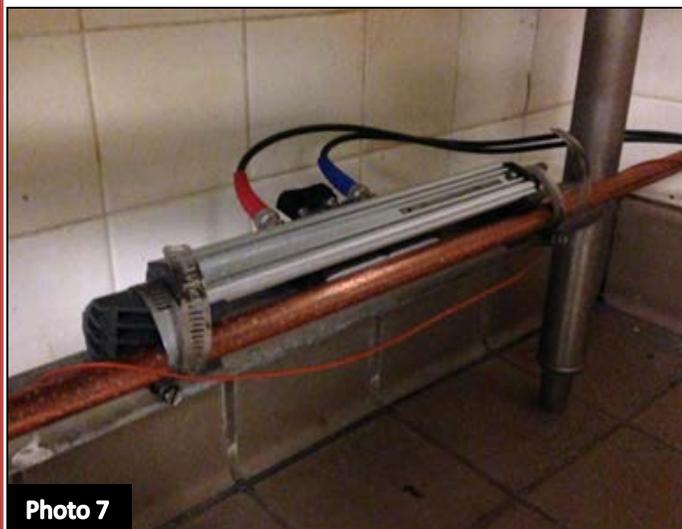
Photo 7

FSTC's clamp-on ultrasonic meters were used to measure the flow rate of the water without cutting any pipes. This equipment was used because the dishwasher is not individually metered. This technology allowed FSTC to isolate water use from the dishwasher. FSTC was able to determine if the dishwasher was working in an efficient manner by analyzing flow patterns, temperature fluctuations, and cycle times.

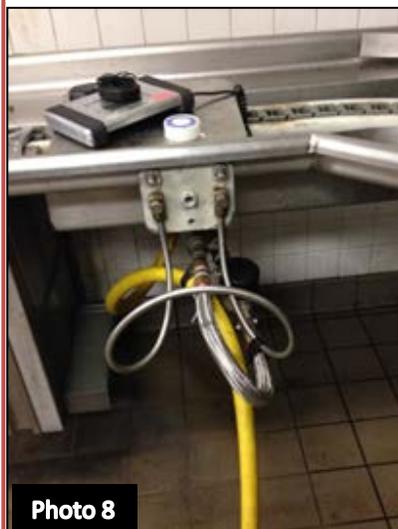
Photo 8

A yellow hose with the metering equipment installed.
